Assessment of Oxidized Cylinder Liners (SY 223/24)

Model Line: **718 (982)**
911 (991)
911 (992)

Concerns: **Cylinder liners with PTWA (Plasma Transferred Wire Arc) coating**

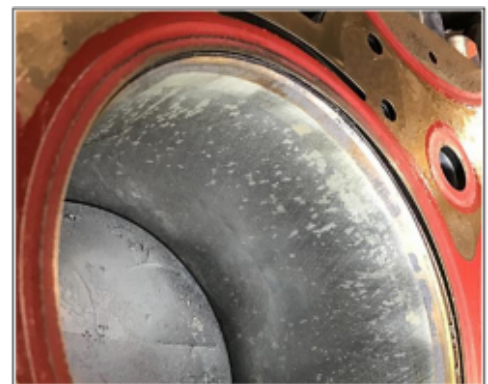
Traces of oxidation corresponding to the sample illustrations must be assessed as **OK**.

Sample illustration of oxidized cylinder liner

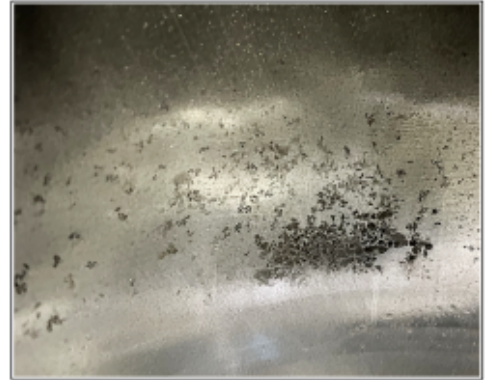
Sample illustration of oxidized cylinder liner

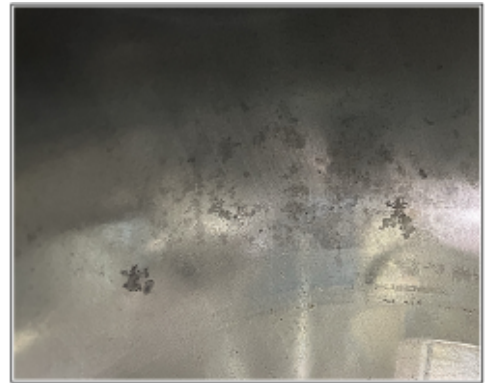
Sample illustration of oxidized cylinder liner

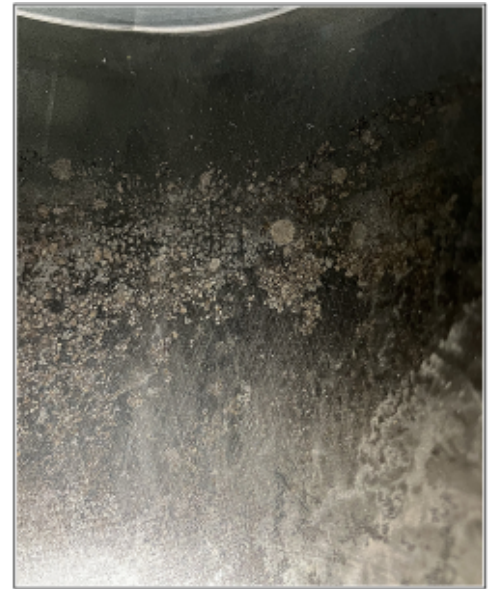
Sample illustration of oxidized cylinder liner
