## Advanced Technical Information

1801.4 4636

### Brake Squeal

Binder - Advanced Technical Information  
This bulletin replaces bulletin Group 4,  
#1801.3, dated 12/08/2020.

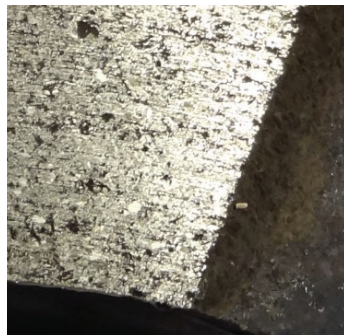
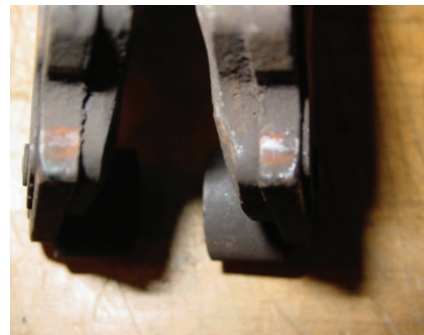
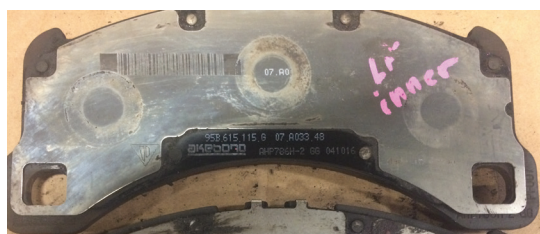
- Glazed surface
- Cracks from overheating
- Dust buildup at edges
- Contamination from sprays such as tire dressings
- Wear at contact points
  - Piston contact on pad shows even or uneven pressure distribution
  - Pad to caliper contact points show how pad moves in caliper
  - Spring to pad contact shows how well spring tensions pad

- Sanding the pad and chamfering the edges
- Insuring the contact points are smooth
- Lubricating contact points with optimol grease
- Insure proper fit and lubrication of shims and/or dampers

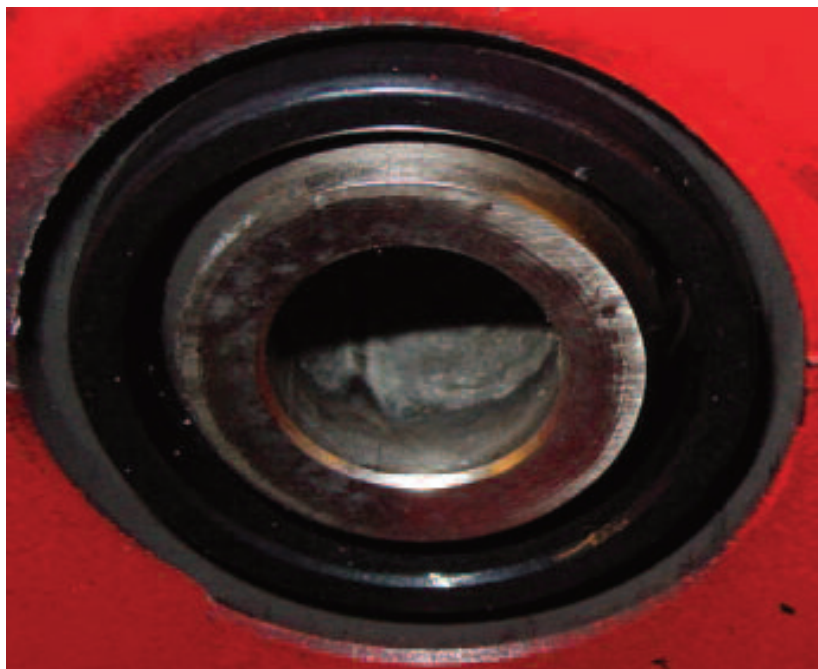
- Wear marks from movement of pad against piston. This is an indication of pressure distribution from the piston to the pad. Brake squeal is affected by pressure distribution, especially at low pedal pressures.

- Inspect pistons to see if there are any that may not be returning completely.
- Exercising the caliper pistons can restore the movement of the piston to normal operation (the brake fluid must also be clean).

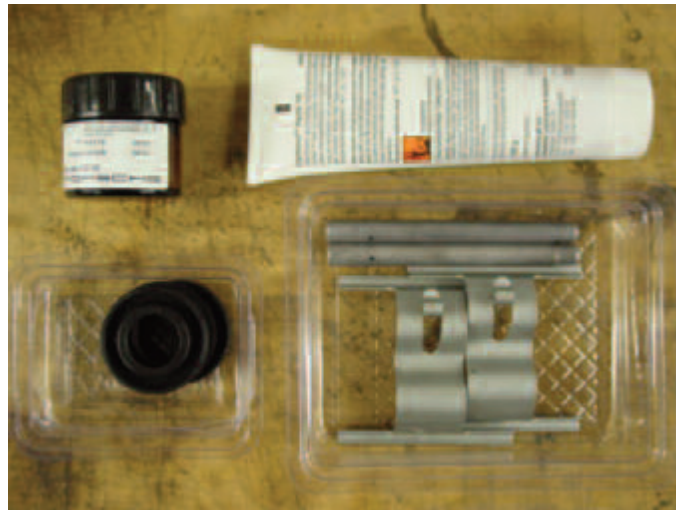
- Remove brake caliper
- Remove pads and hardware
- Have the following parts on hand:
  - Caliper paste 000.043.117.00
  - Optimoly paste 000.043.020.00 (the 100g tube should last through several repairs)
  - New hardware kit
  - New dust seals

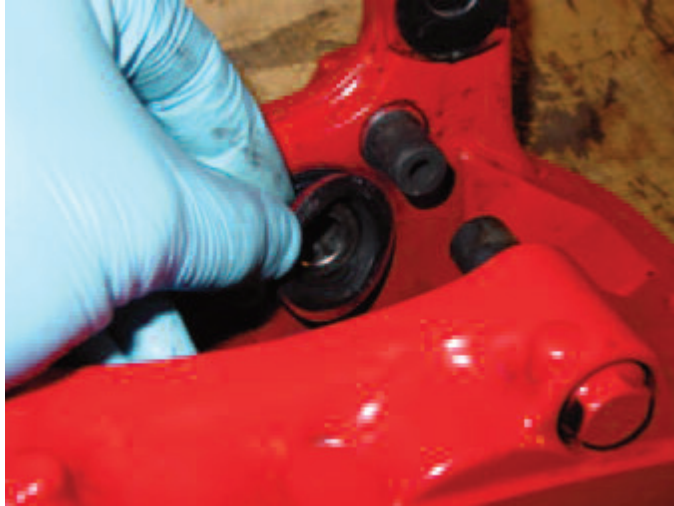
- Remove dust seals from the caliper pistons

- Extend the pistons against a block of wood to keep them from coming out of the caliper. (It may be necessary to retract and extend the pistons several times to free up the movement)
- Apply brake caliper paste to the piston and install new dust seals on the pistons
- Retract the pistons and seat the dust seals
- Install pads and new hardware
- Install caliper on vehicle
- Flush brake fluid
- Test-drive the vehicle
